**Town of Clayton, North Carolina  
Request for Proposal**

**220 E. Main Street  
Clayton, North Carolina**

# ASBESTOS SURVEY AND LEAD PAINT SAMPLING REPORT

**LA - 10235: 220 E. Main St, Clayton, NC**

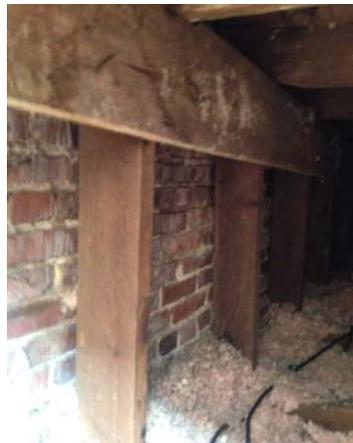
5. Typical roof truss at wall

1. The roof trusses appear to be in good condition, but will need structural reinforcement.
2. The bearing of the trusses at the masonry walls will need to be investigated further after demolition.
3. The roof decking appears to be in good condition based on limited inspection.
4. The roof appears to be in fairly good condition.
5. Note - The exterior masonry appears to be in fairly good condition given the age of the building. Further inspection should be made after vegetation has been removed from the rear of the building.

4. Inspect the roof truss bearing locations and conditions after demolition and reinforce if necessary.

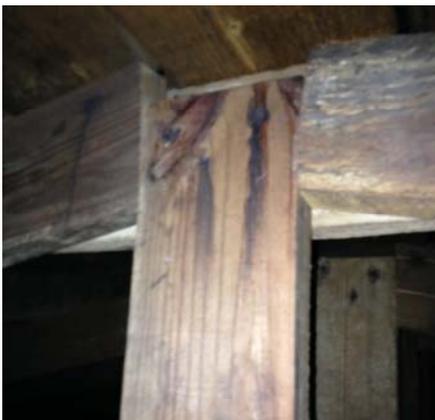
7. Roof truss nailed connection

5. THE TRUSS CONNECTIONS ARE NAILED.
6. THE ROOF DECKING MATERIAL IS 1 X 8 NOMINAL WOOD.
7. THE SECOND FLOOR CEILING IS ATTACHED DIRECTLY TO THE BOTTOM OF THE ROOF TRUSSES. THE CEILING MATERIAL IS 1 X 4 TONGUE AND GROOVE WOOD.

1. ADD BOLTS AT THE DIAGONAL WEB TO CHORD JOINTS.
2. ADD 2 X 4 LATERAL BRACING AT THE DIAGONAL WEBS.

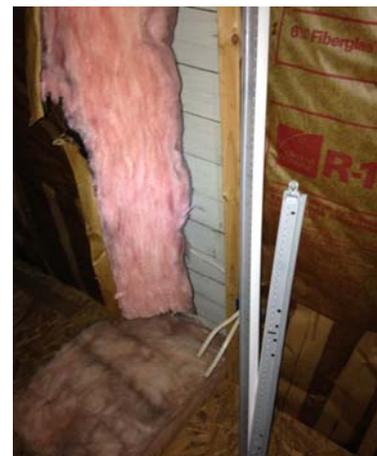
9. shared wall at 218 E. Main

8. THERE IS NO ATTIC INSULATION IN THE 220 SPACE. THERE IS LIKELY INSULATION IN THE ROOFING SYSTEM.
9. THERE IS NO FIRE WALL OR ANY SEPARATION BETWEEN THIS SPACE (220 E. MAIN) AND THE ADJACENT SPACE (218 E. MAIN ST.) THERE IS ATTIC INSULATION IN THE ADJACENT SPACE.

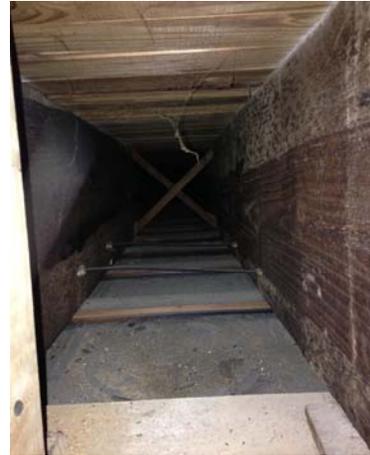
15. 2nd floor joists

1. There is no apparent excessive sagging or sloping of the second floor.
2. The floor joists appear to be in good shape pending inspection after demolition.
3. The wood ceiling is in fair to poor condition based on limited inspection.
4. The non-structural walls and ceilings are in fair condition, but are specific to the previous tenant.

1. Inspect the joist bearing conditions, particularly the masonry beam pockets, after demolition. If the pockets are not adequate, a steel support angle may need to be installed to support the joists.

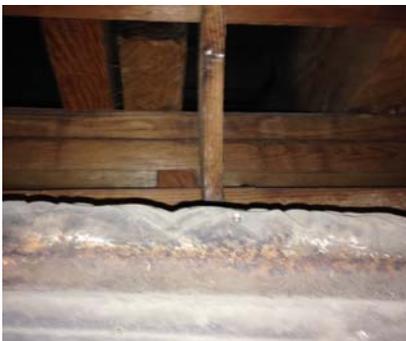
16. Joist bearing at 1st floor wall

1. The crawl space is very shallow and not accessible.
2. The floor joists have deteriorated and have insect damage.
3. The floor is sloping badly, particularly in the rear.
4. The exterior walls appear to be in good condition with limited access for inspection.
5. The added non-structural walls and offices are in fair condition, but specific to previous use.

The building can be made suitable for future commercial use by performing structural upgrades to the building. The first floor should be removed and replaced with a concrete slab on grade due to the condition of the existing floor joists and floor. The second floor can be reinforced to support office and assembly live load by adding steel beams at mid-span. The existing roof trusses need to be reinforced at the connections to adequately support the roof loads. These structural reinforcements are explained in the structural recommendations section of this report.
